Subject: Issuance of Findings of Violation and Order for Compliance for NPDES Permit Violations

Exhibit 1
Marisco, Ltd.
NPDES Permit No. HI0021786
Drydock Cycling Effluent Limitation Violations
April 2007 – November 2008

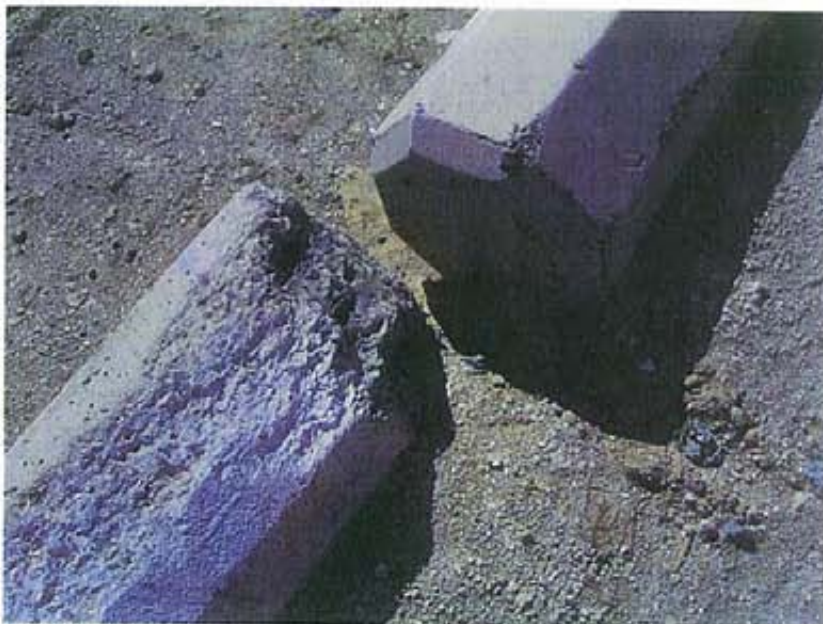
Photo 55: Another gap in the berm.

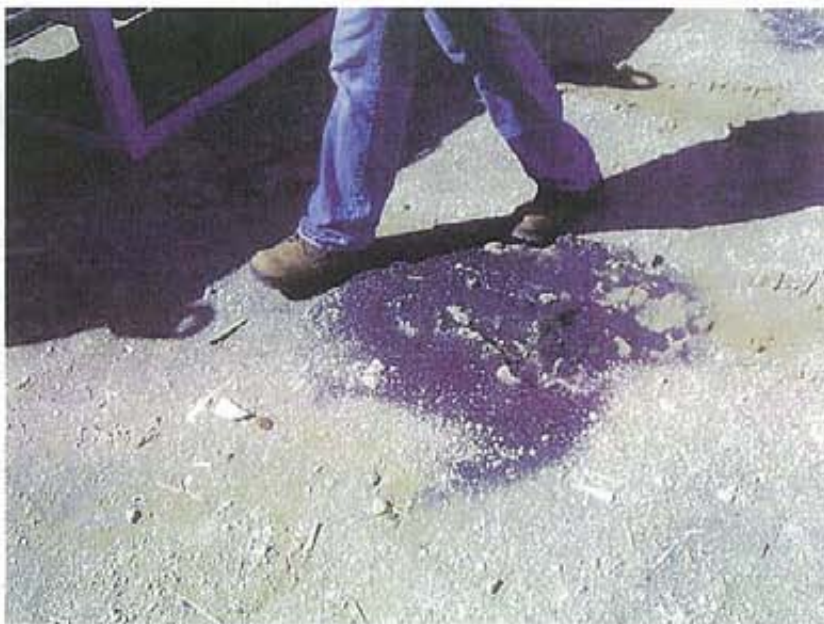
- iii. Sand blasting grit was observed spilled on the ground, shore side of the dry dock and multiple bags of fresh sand blasting grit were observed stored on-site without cover, inconsistent with Part B.2.j of the permit and with the land-based operation BMPs of the Marisco's BMP Plan, which states that sand blast grit [new or spent] will be covered; and

Photo 56: Sand blasting grit was observed on the ground, exposed to potential storm water runoff.

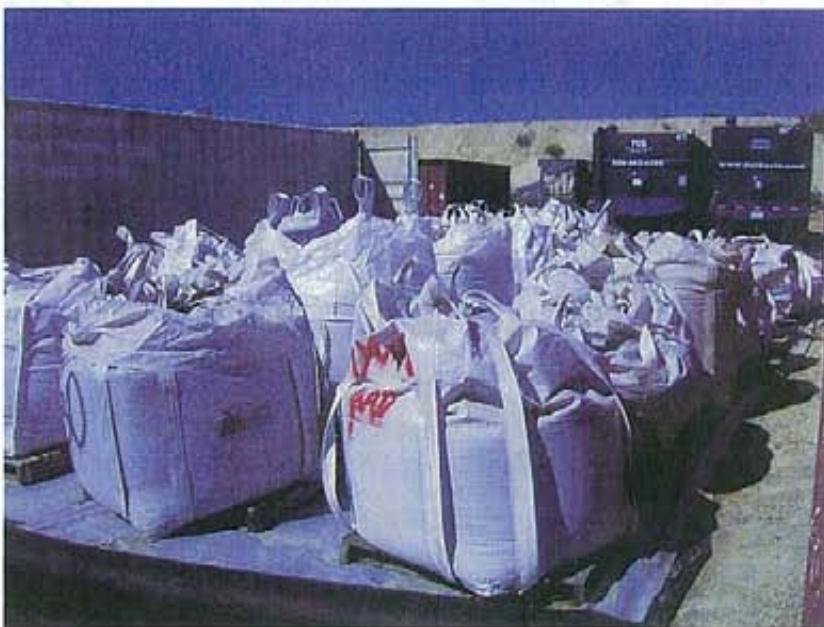
Photo 57: Sandblast grit stored on-site, un-covered.

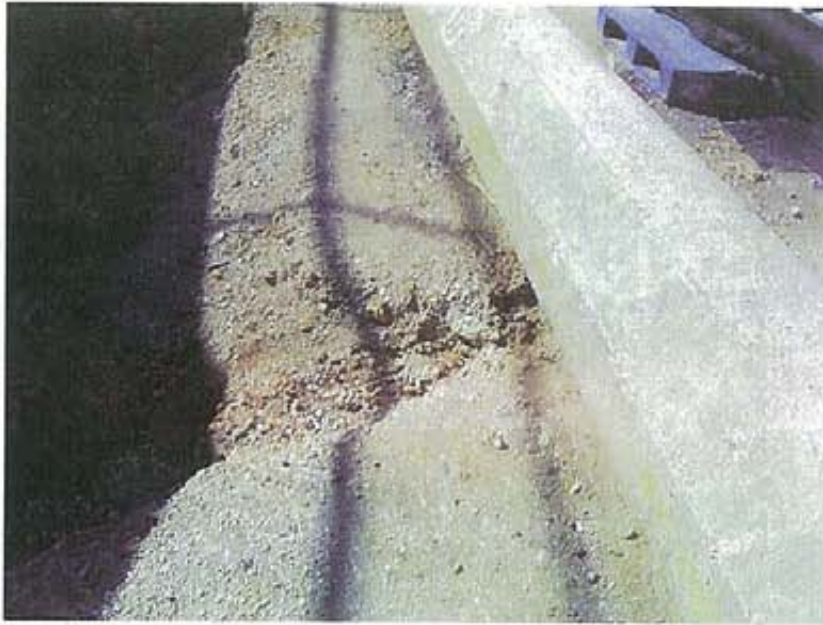
Photo 58: Another gap in the berm.

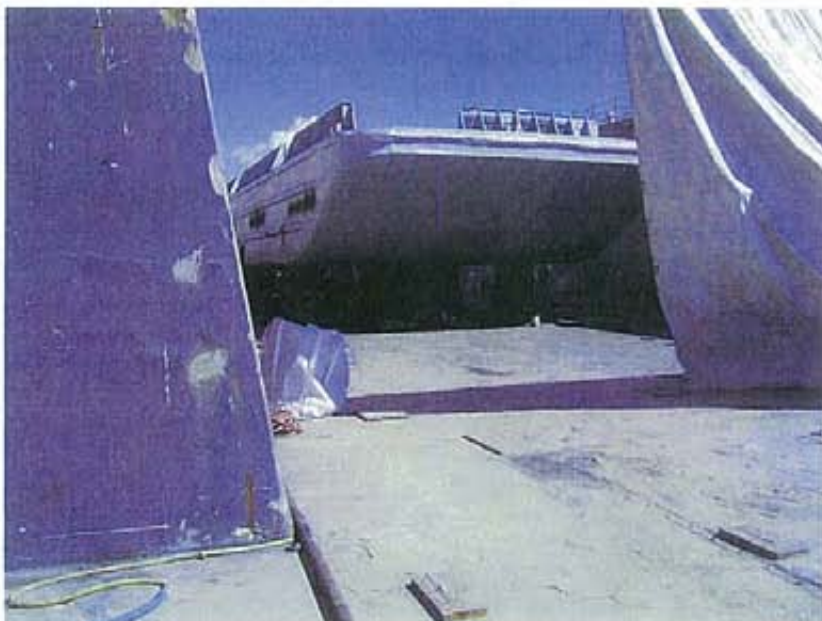
Photo 60: A vessel was docked in the Lil' Parris dry dock on the date of the inspection. Work on the vessel was not performed in the presence of the inspector; however work on the vessel had occurred early in the day.

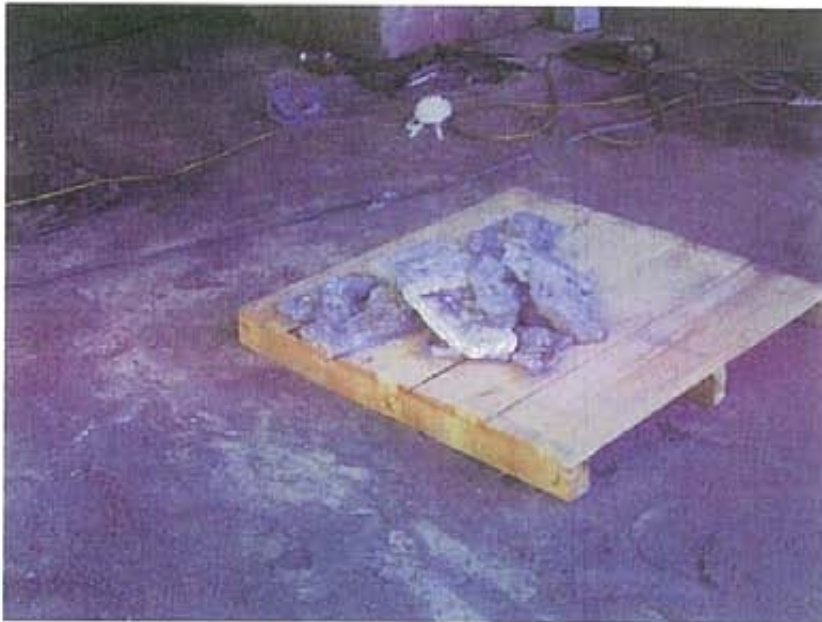
Photo 61: Zinc anodes were observed stored on the dry dock, uncovered and exposed to potential rain fall.

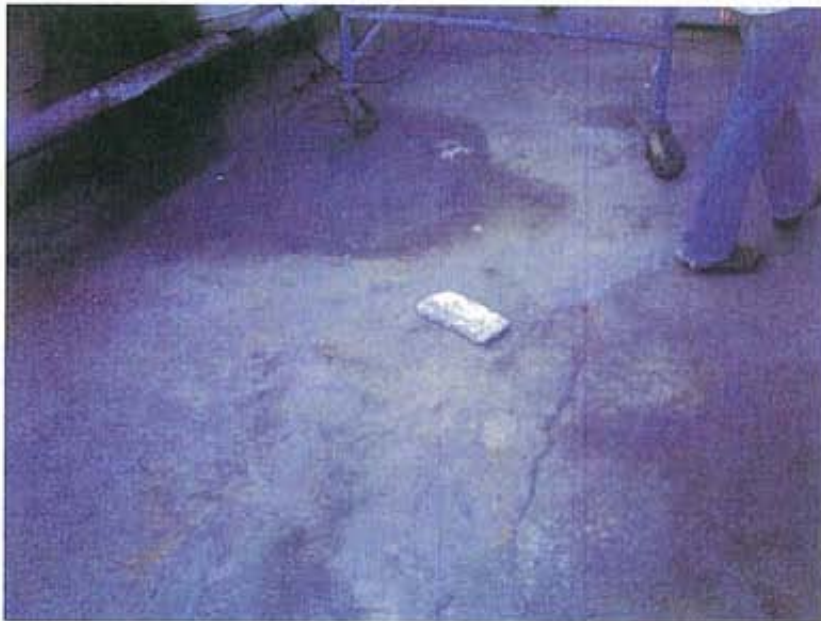
Photo 62: A zinc anode was observed on the floor of the dry dock, exposed to potential storm water runoff.
